Federal Lead Smelter - East Side
LPC# 1190105308/1191155020
Madison County
SF/HRS

CERCLA Expanded Site Inspection

**Federal Lead Smelters (ASARCO)-East Side
Alton, Illinois**

February 11, 2020

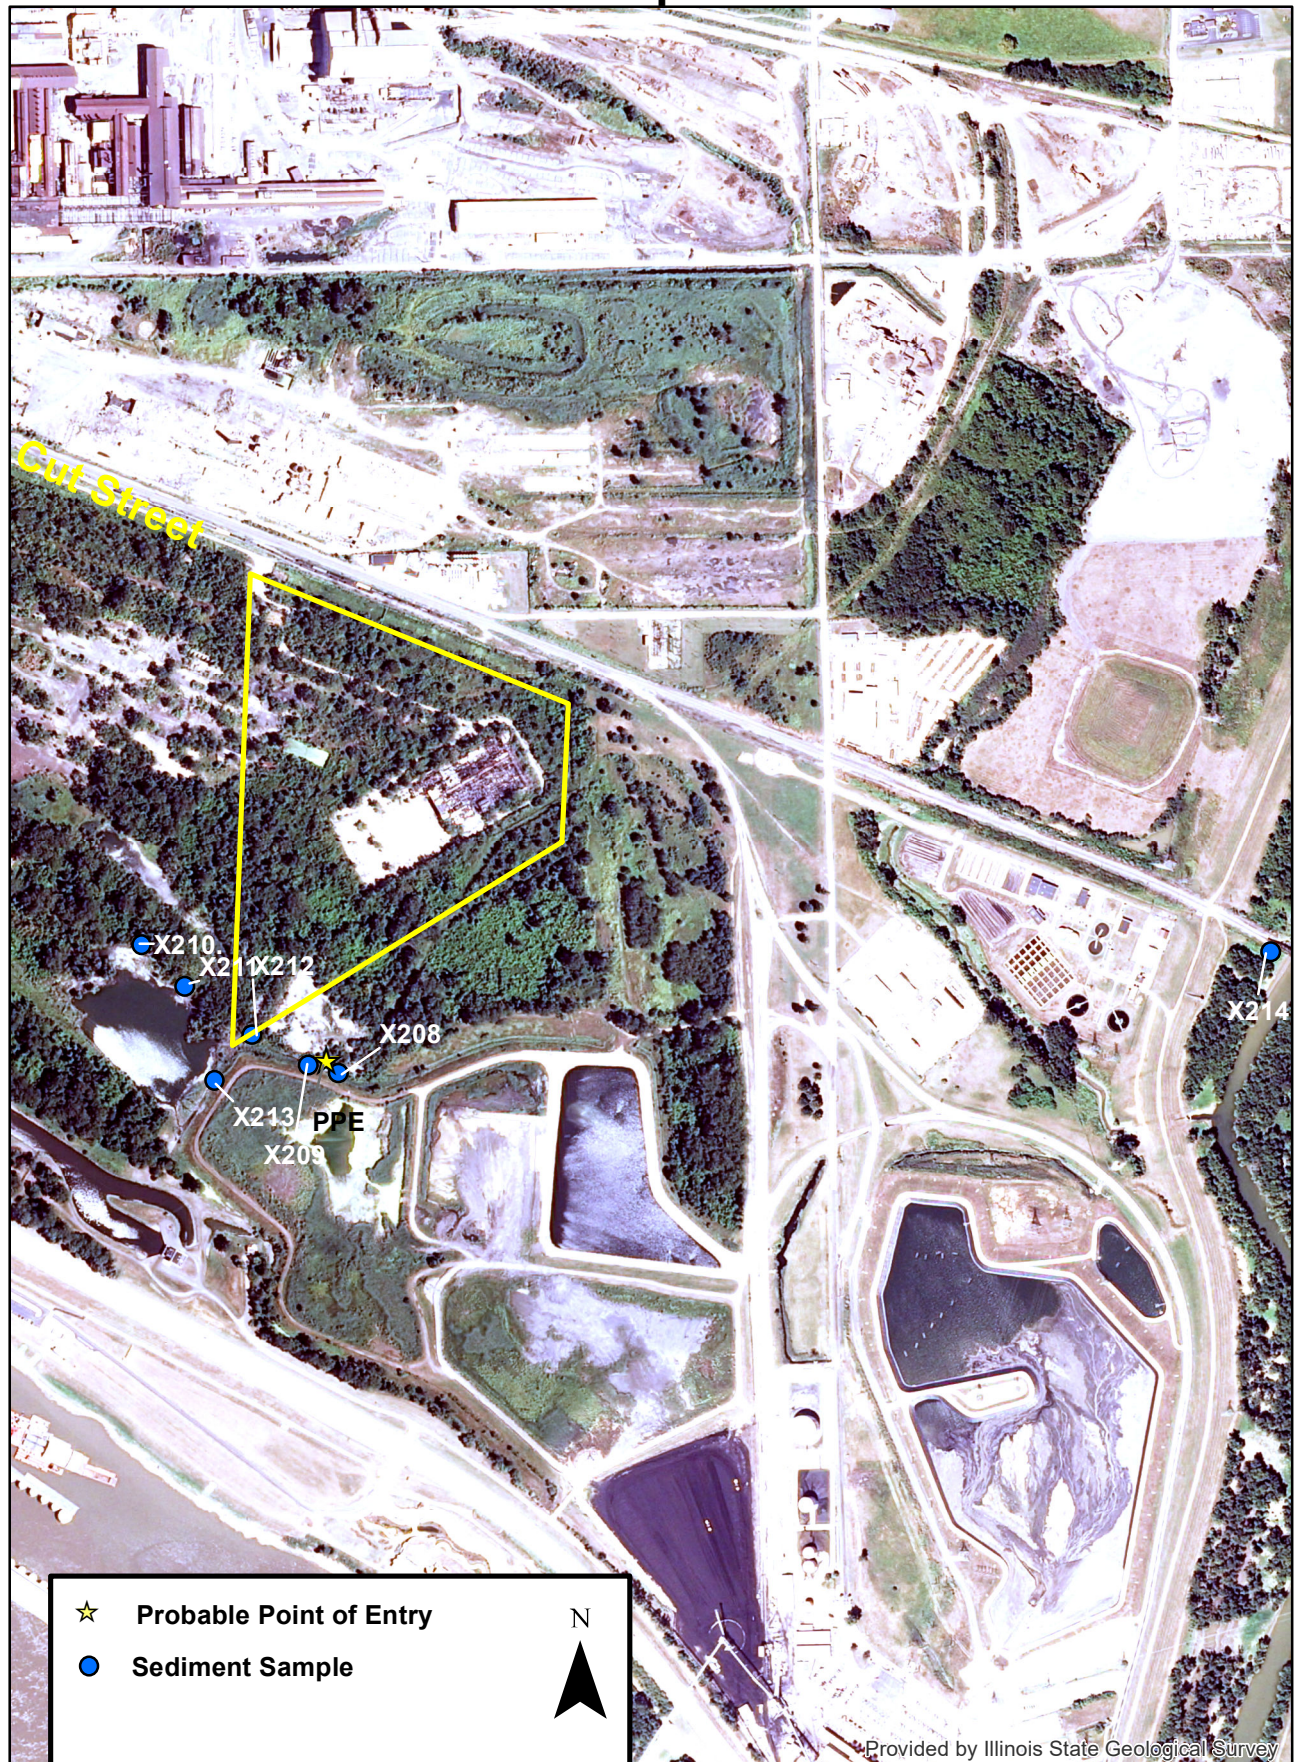
Federal Lead Smelter Expanded Site Inspection Soil Sample Locations

Soil samples were collected from various locations on the property (X115 – X123) and off the property (X124 and X125). The sample locations were based upon past industrial activities that took place and metal concentrations as identified by the XRF screening tool. The XRF was used to document potential vertical migration within the top two feet (Table 6). Data obtained from the XRF were instrumental in selecting the analytical sample location and depth during the investigation. The soil sample locations can be found in Figure 3. All soil samples collected from the site were collected from material associated with historical activities that took place on the site associated with the lead and aluminum smelter. There were five TCLP samples

collected and were obtained from the same soil sample location as sample X115, X118, and X120 – X123 (Figure 4). There was one background soil sample, X125, collected off-site at the Clara Barton School located approximately 1.7 miles to the north. All soil samples were collected using a stainless-steel trowel and deposited into a clear 16 oz. jar. Tables 1 and 3 contain the lab data for all soil samples collected.

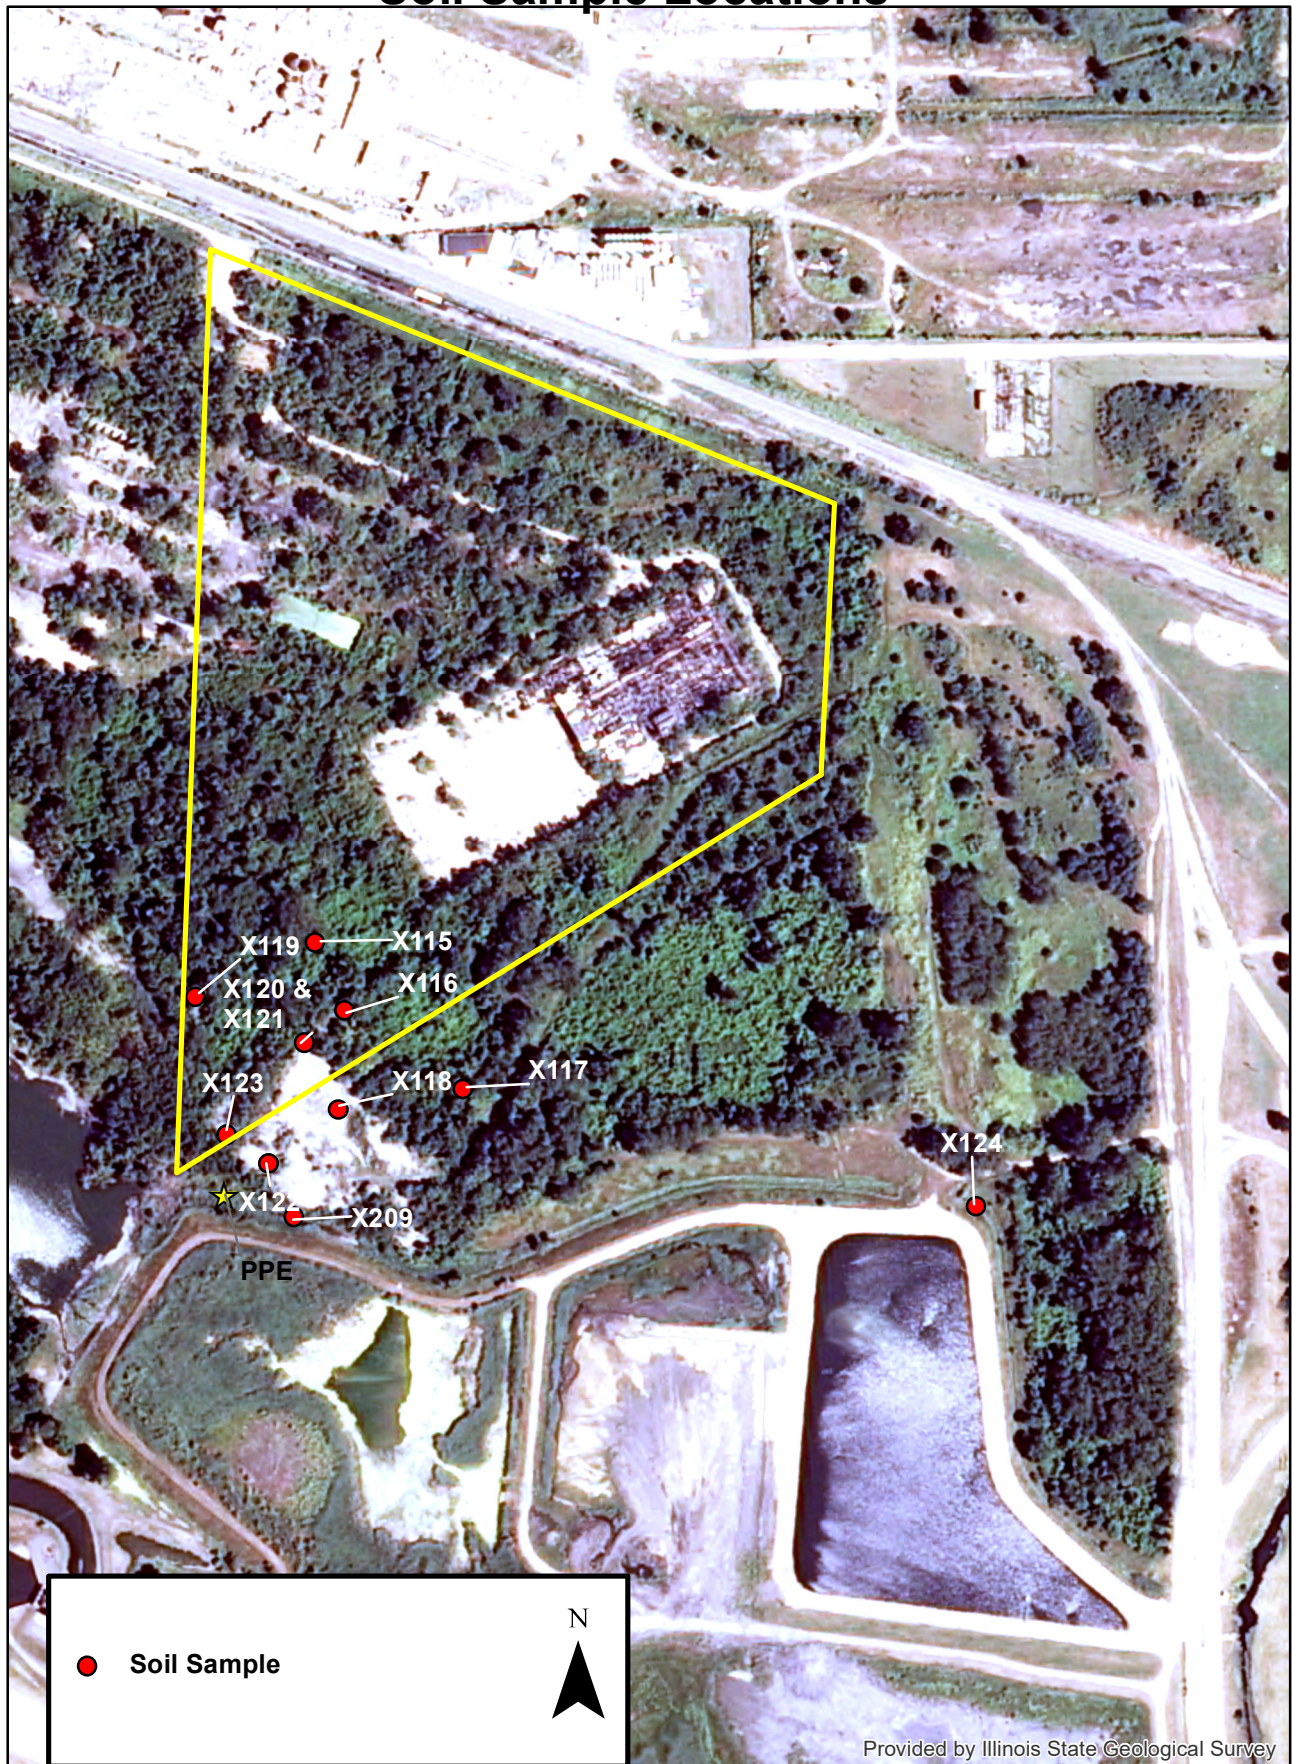
Federal Lead Smelter Expanded Site Inspection TCLP Sample Locations

Tables 1 and 3 contain the lab analysis for all soil samples collected. Sample X125 is the background sample used to compare release samples and evaluate for observed release. No release samples were collected within 200 feet of a residence, daycare, or school. Ten release samples and one background sample were analyzed for total metals and PCB. Figure 3 and 4 show the location of all soil and TCLP locations on a map. All release samples except one, X124, contained at least one hazardous substance above three times background. The main hazardous substance associated with all samples and that met observed release criteria was lead which ranged from 633 mg/kg to 3,250 mg/kg. In addition to meeting observed release criteria for lead, removal management levels were also exceeded for lead. Other hazardous substances that met observed contamination criteria for inorganics was zinc, 2,890 mg/kg to 18,000 mg/kg; antimony, 14.2 mg/kg to 40.4 mg/kg; and chromium, 230 mg/kg to 465 mg/kg. There were also seven samples, X116-X122 that had observed contamination for PCBs. The readings for the PCB release samples varied from 46 ug/kg to 21,000 ug/kg. Samples collected from the waste pile also had observed contamination concentrations of PCB. Figure 3 shows the soil samples collected during the ESI. Toxicity Characteristic Leaching Procedure (TCLP) were also taken during the ESI and one sample T108 exceeded TCLP numbers for lead and cadmium (Table 5 and Figure 4).

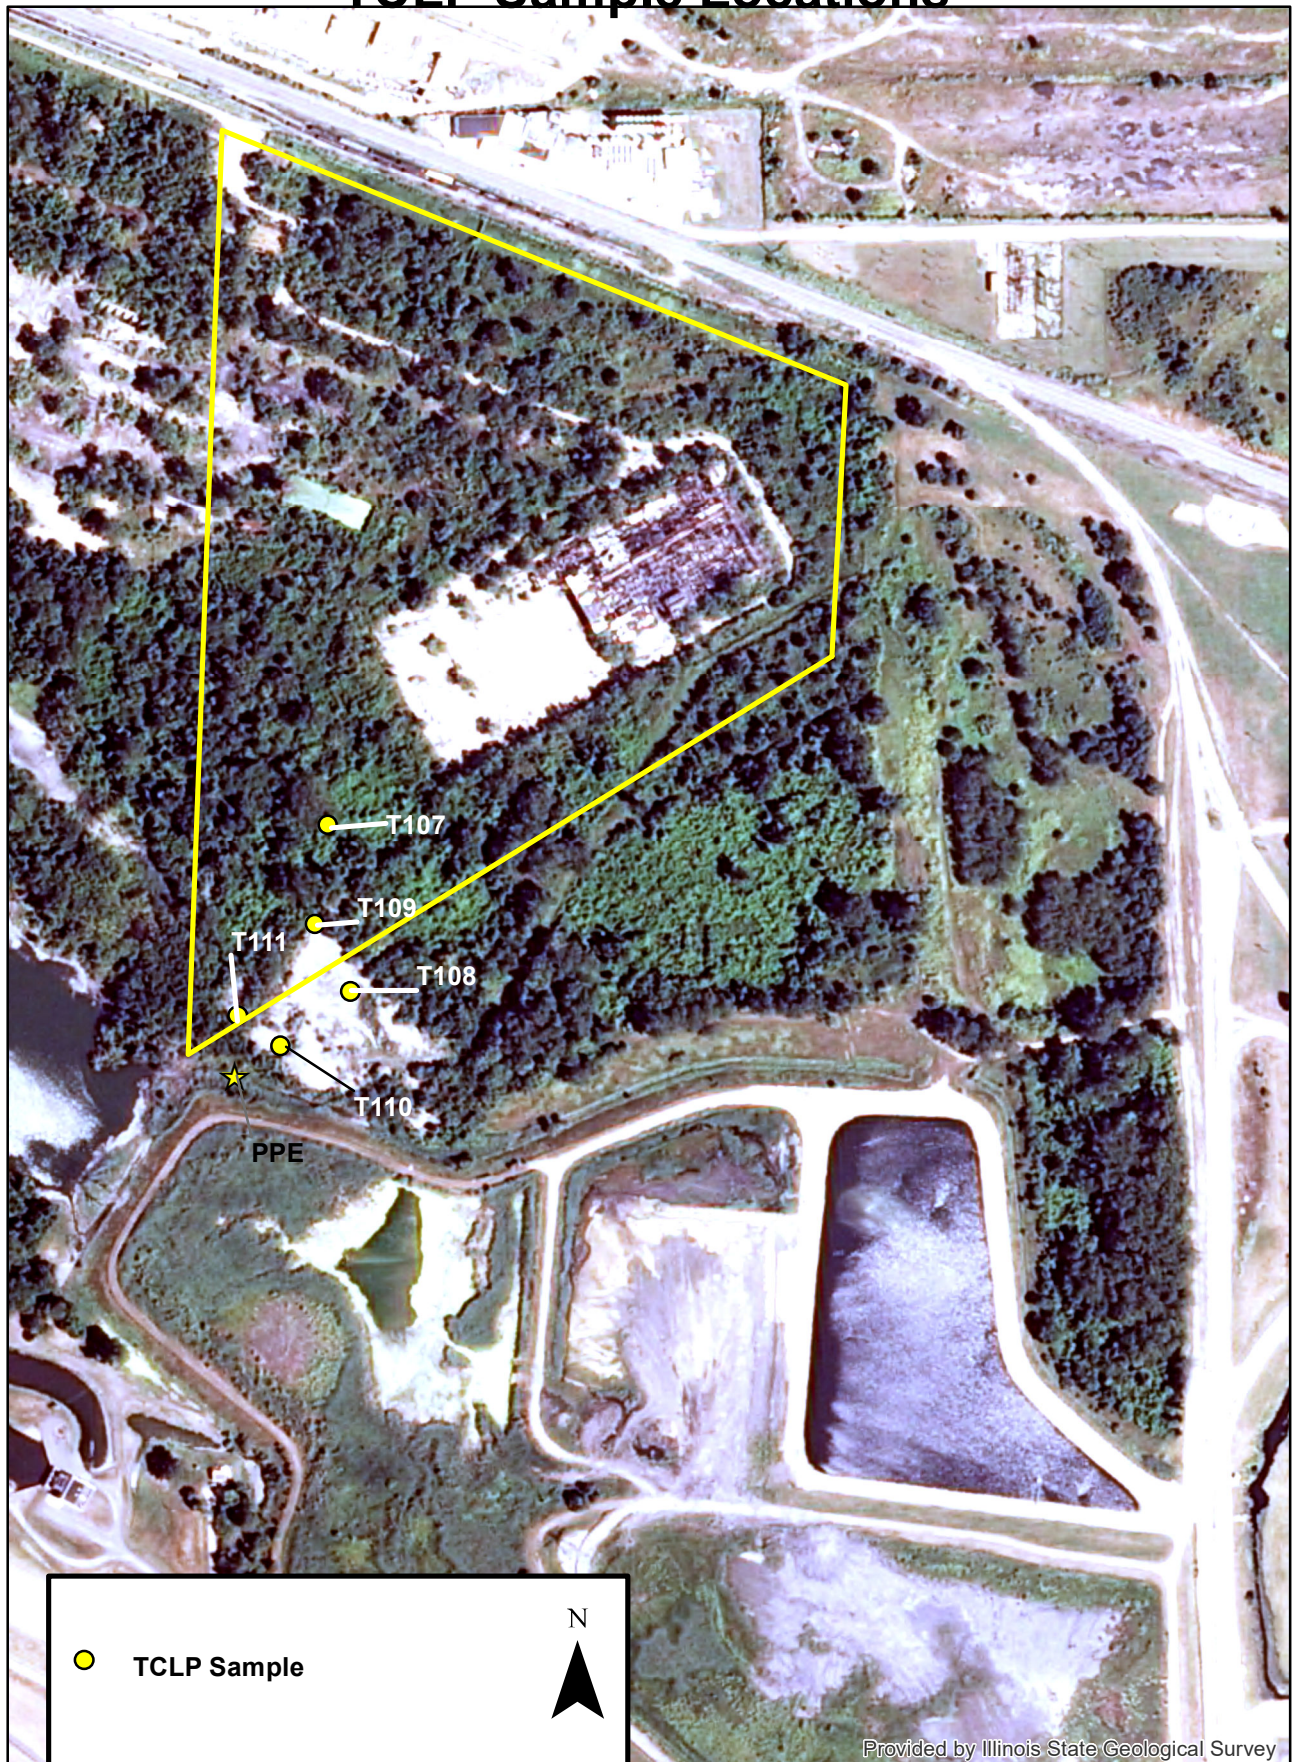
Federal Lead Smelter Expanded Site Inspection XRF Sample Locations

In addition to the samples collected, an X-Ray Fluorescence (XRF), which is used for the screening of inorganics in soil and sediment media, was used to screen all soil and sediment samples collected and assist in the location of sample collection (Table 6). Some notable readings acquired from the XRF included lead at 4841 mg/kg and zinc at 21,167 mg/kg. Soil samples were collected from XRF locations with elevated readings. The XRF data assisted in identifying hazardous substances located in potential sources and migration pathways impacted by the hazardous substances. This data was crucial in establishing analytical release sample locations. Figure 5 of this report shows XRF location information.

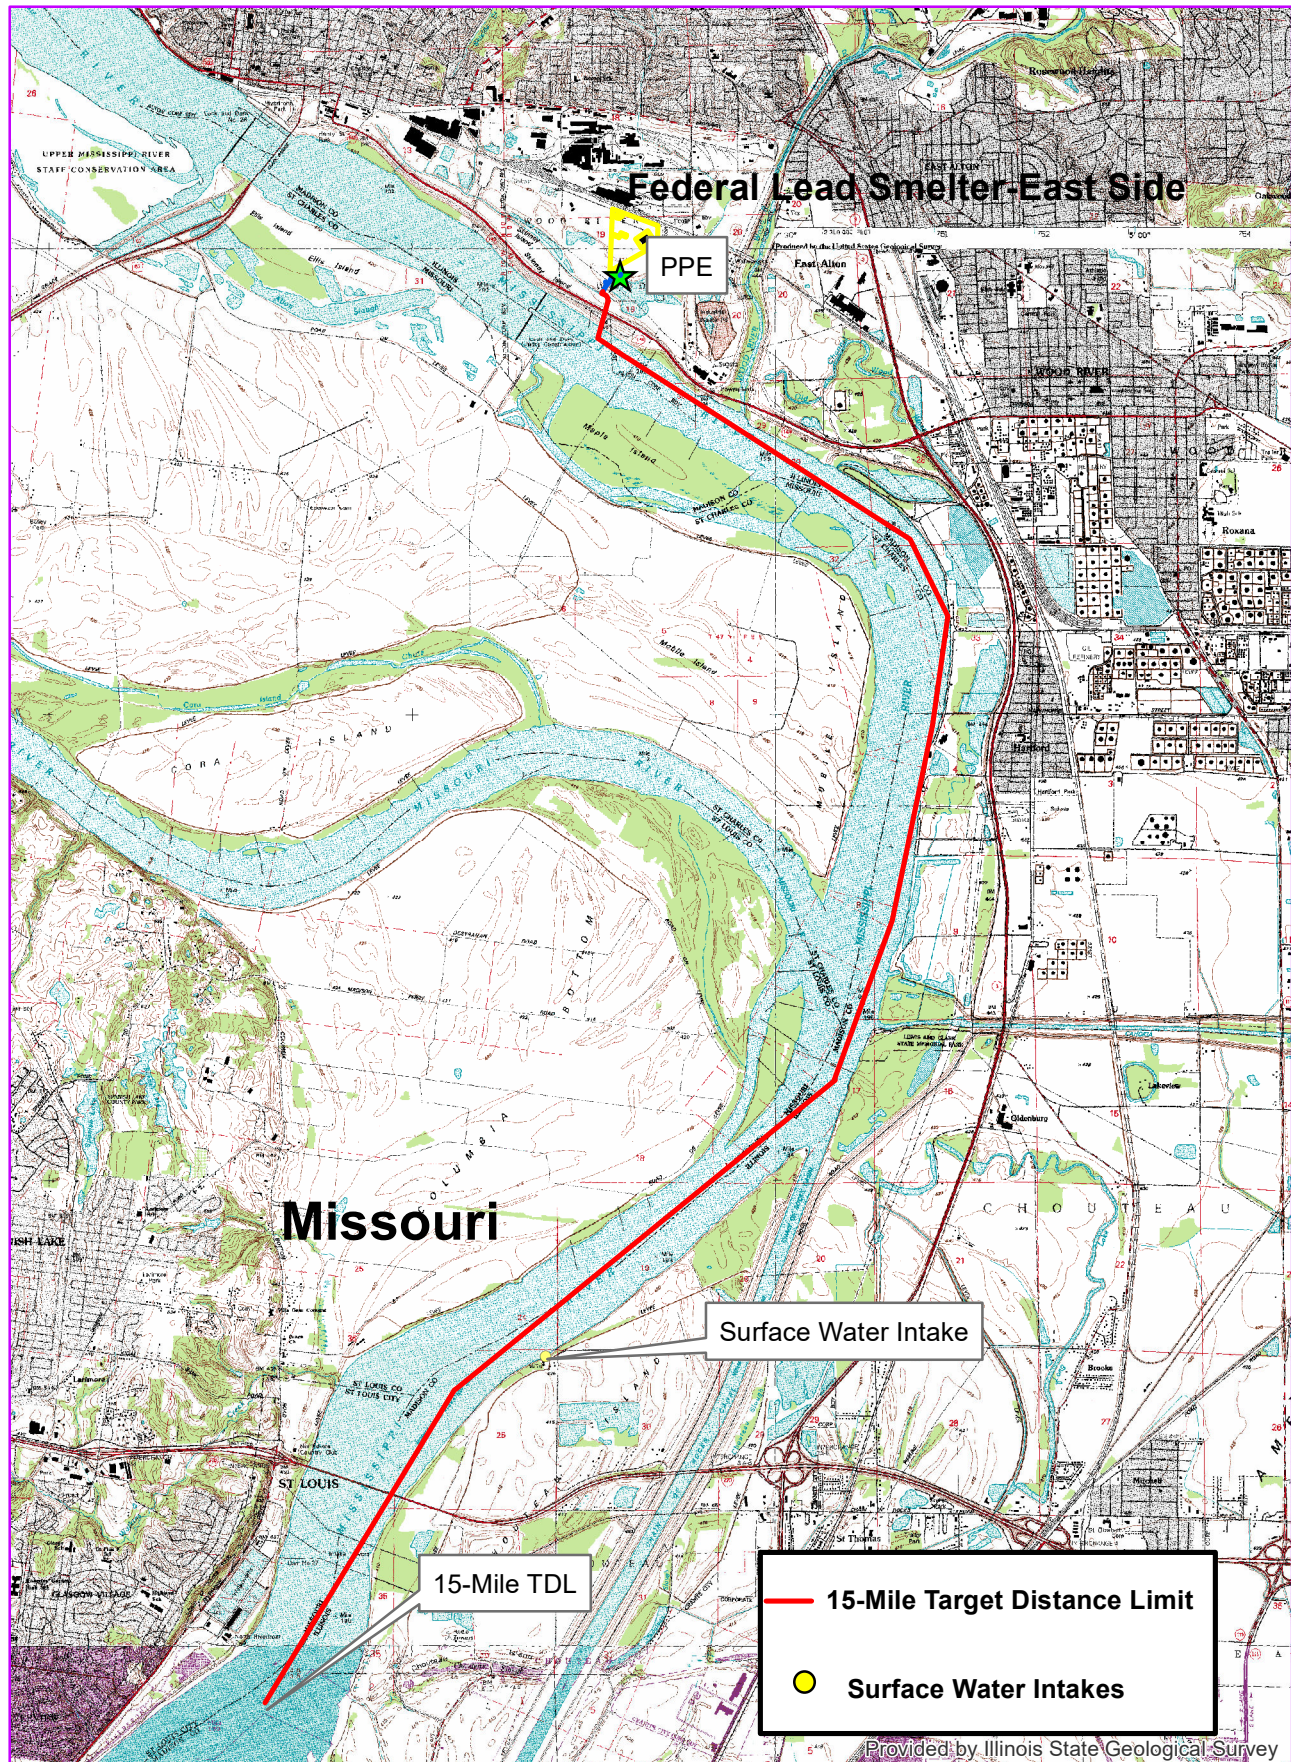
Figure 6
15-Mile Target Distance Limit

to the TDL. The surface water migration pathway is discussed in the following sections. The in-water segment and overland flow of the surface water pathway is illustrated in Figure 6 and Figure 8. The 15-mile in-water segment included the unnamed drainage channel, retention pond, and the backwaters of the Mississippi River make up the overland flow segment for the site.

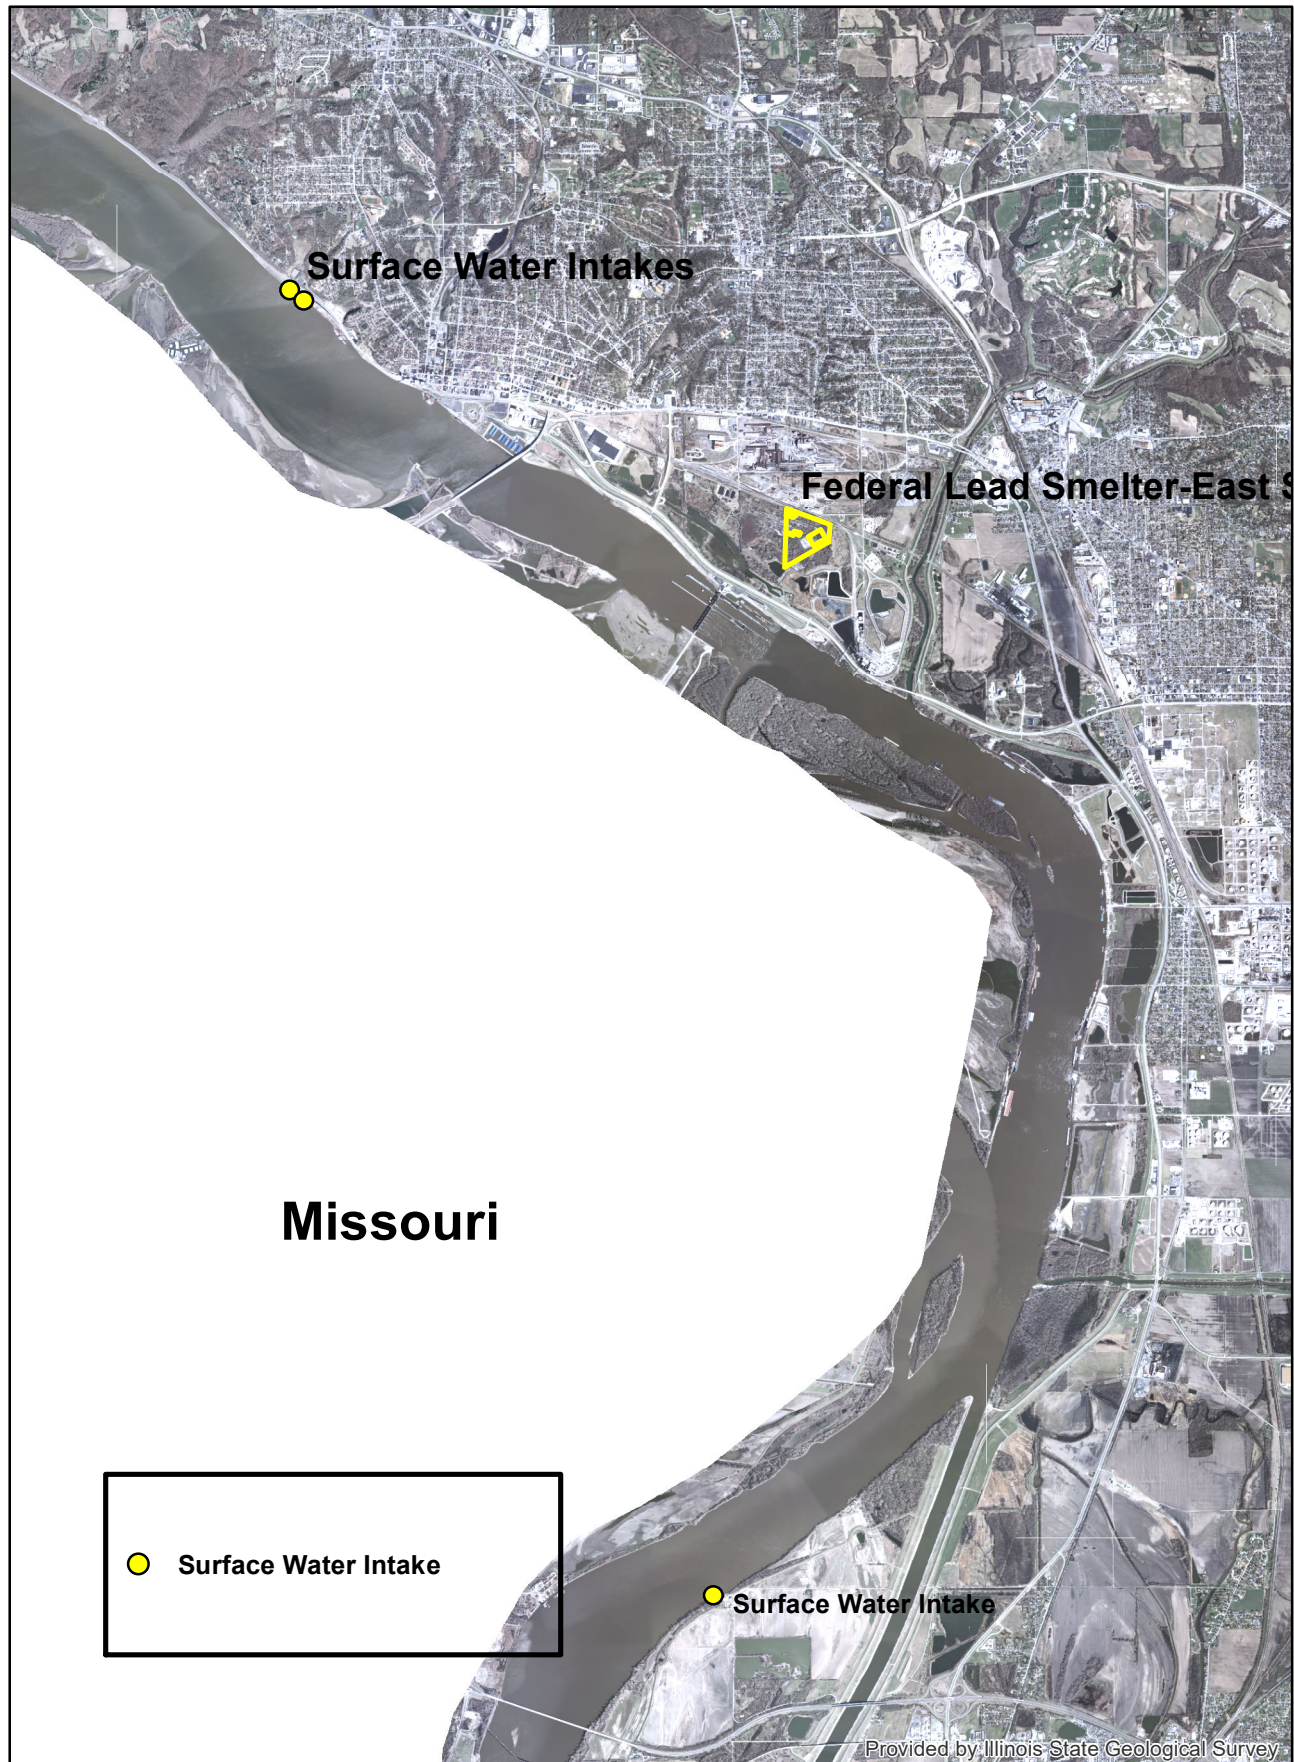
Figure 7
Surface Water Intakes

The groundwater pathway is of little concern at this time due to potable drinking water for the area being supplied by the Illinois American Water Company, which uses the Mississippi River as the primary drinking water source. The surface water intakes are upriver of the TDL in the Mississippi River (Figures 6 & 7). There is also one intake downriver as well.

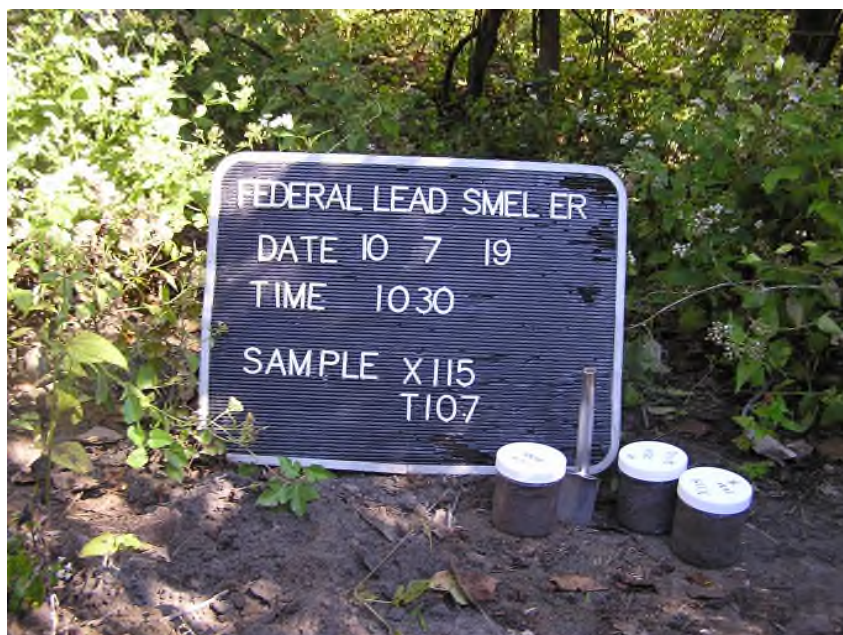
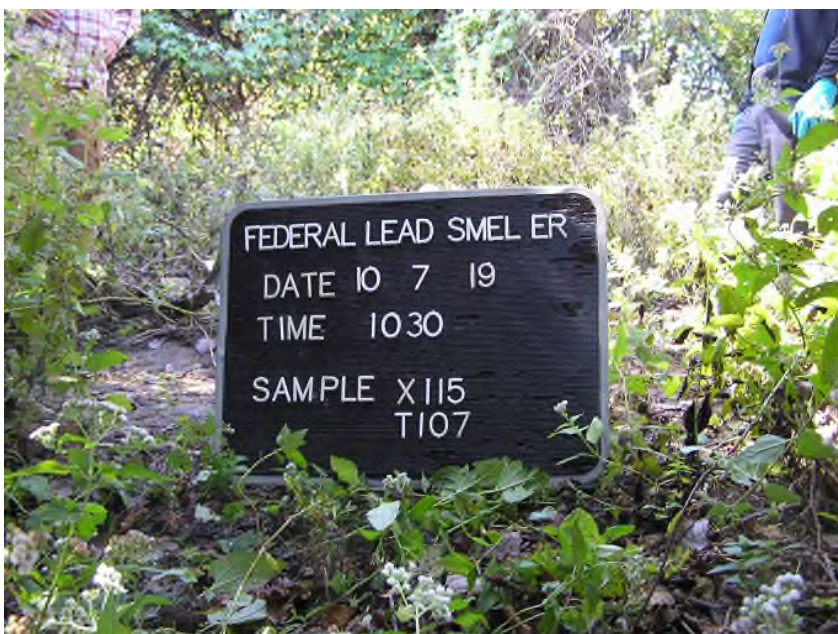
COMMENTS: X115 was collected from the surface to 2 inches; material consisted of silty waste material. Collected from XRF3 location. TCLP 107 was also collected here.

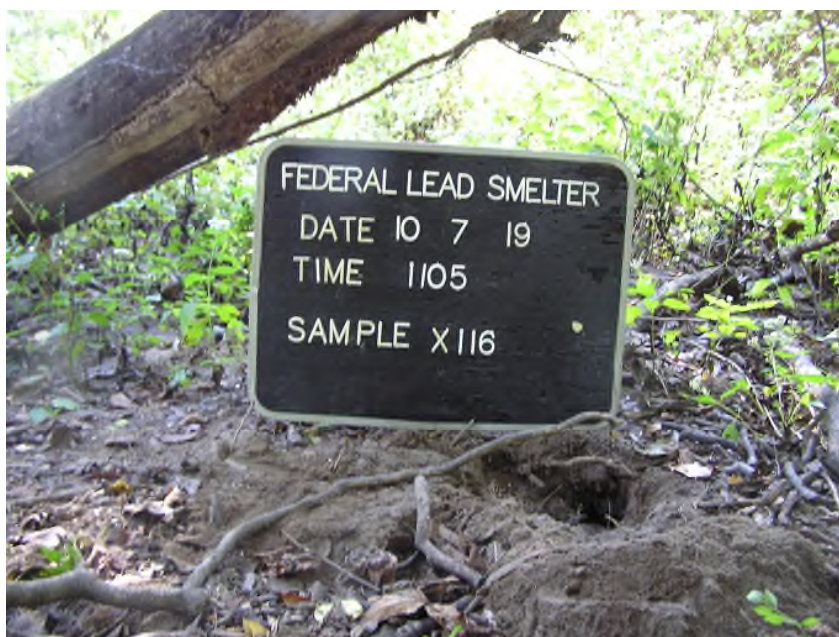
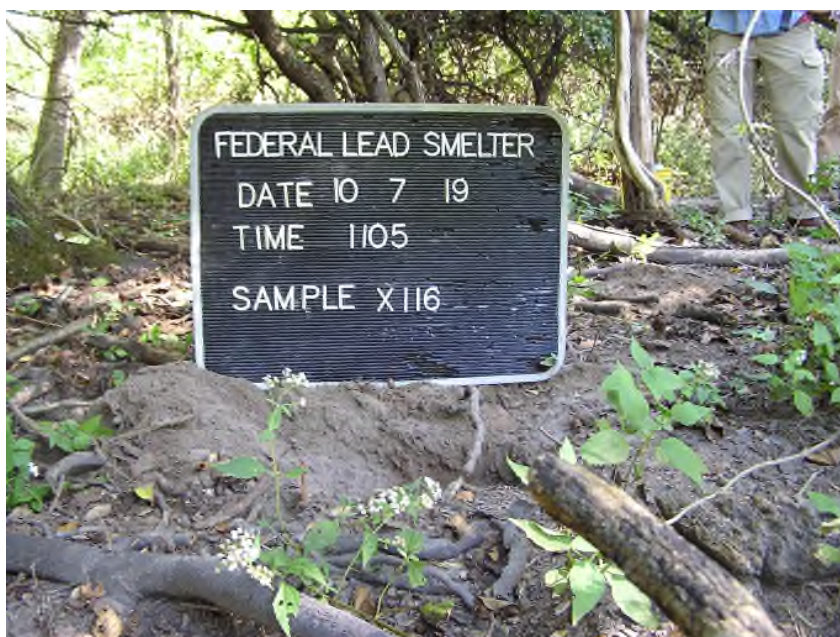
COMMENTS: X116 was collected
from 4 inches near XRF8 location.
Gray silty waste material.

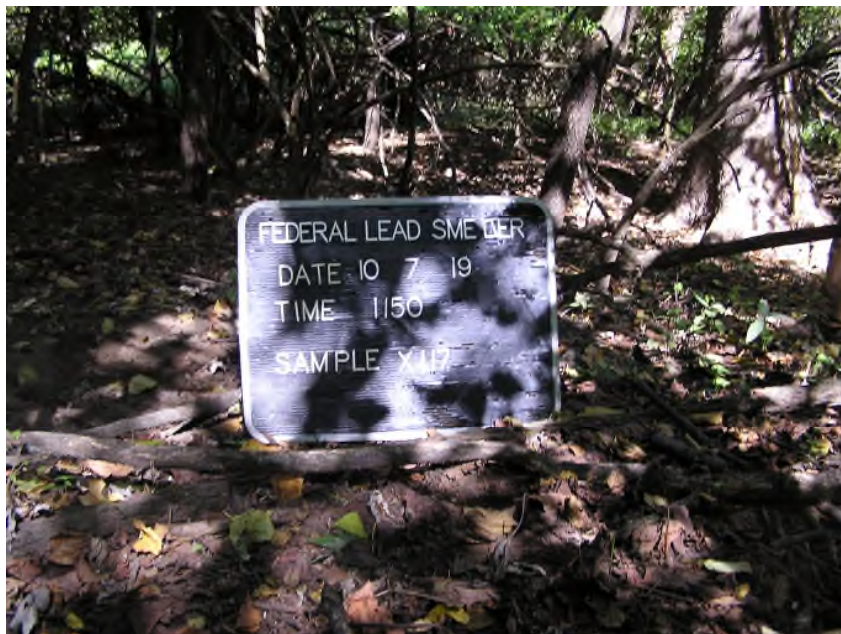
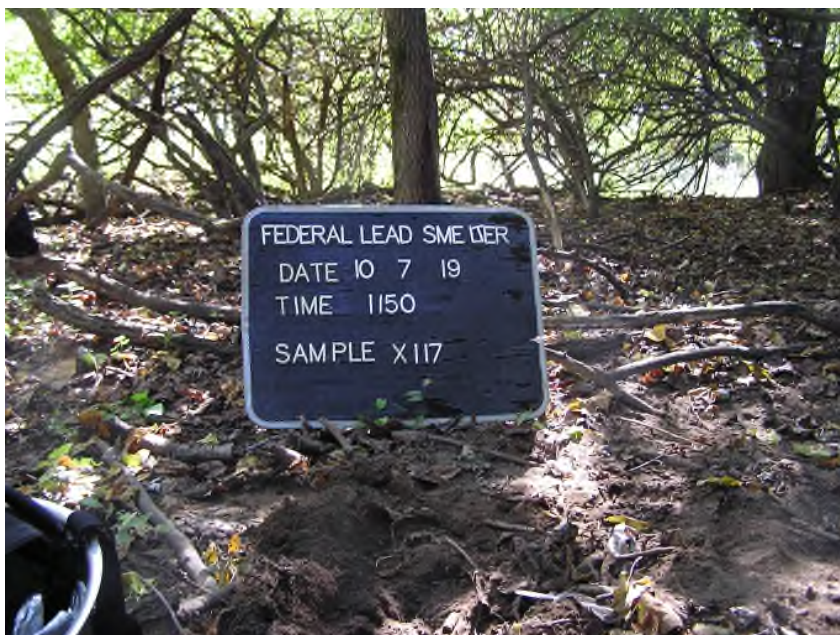
COMMENTS: X117 was collected
from 4 inches in gray silty waste
material at XRF17.

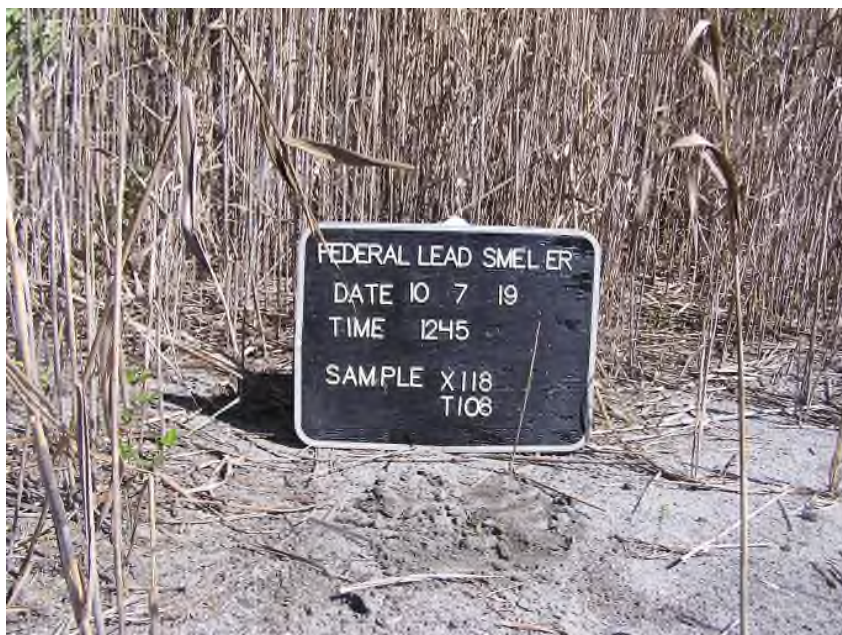
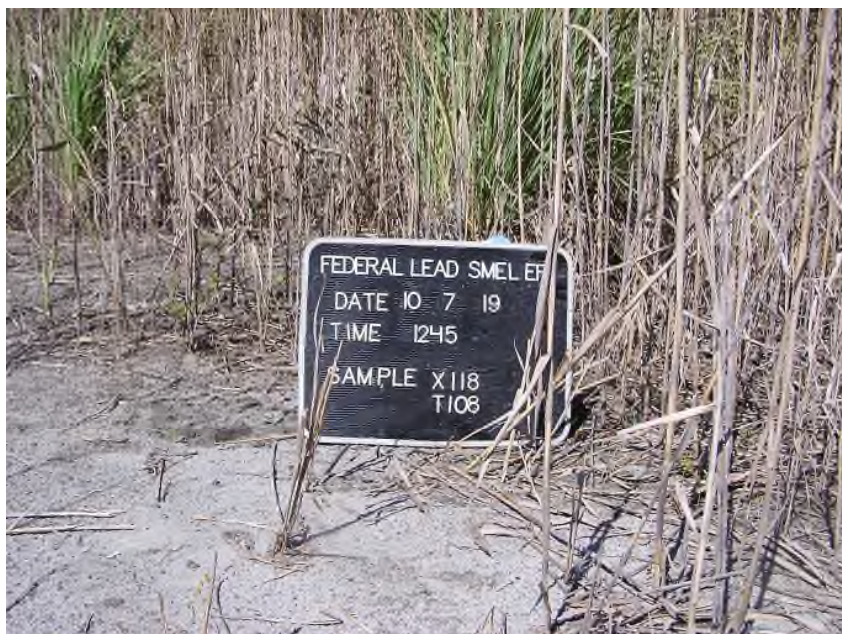
COMMENTS: X118 and TCLP 108
was collected from the waste pile;
sandy grayish silty sand and waste
material.

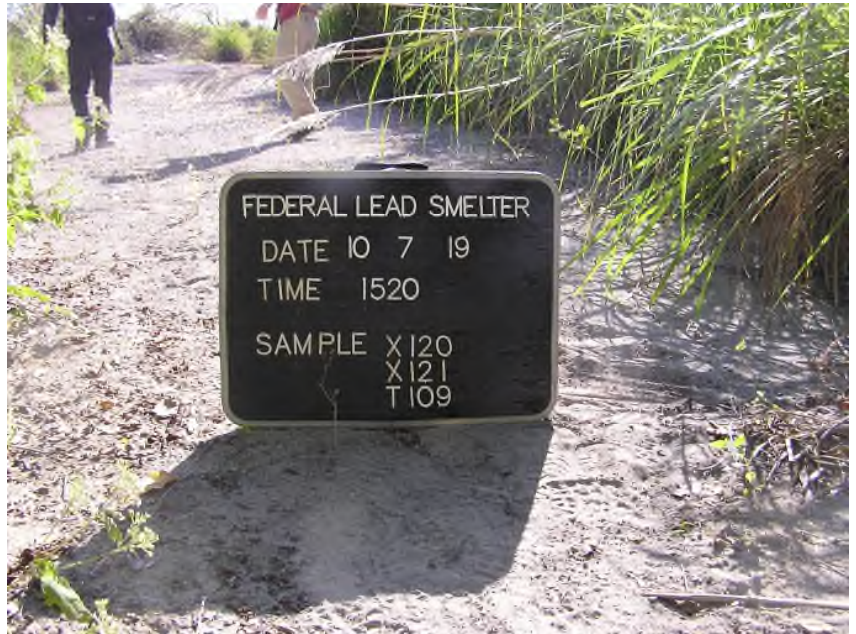
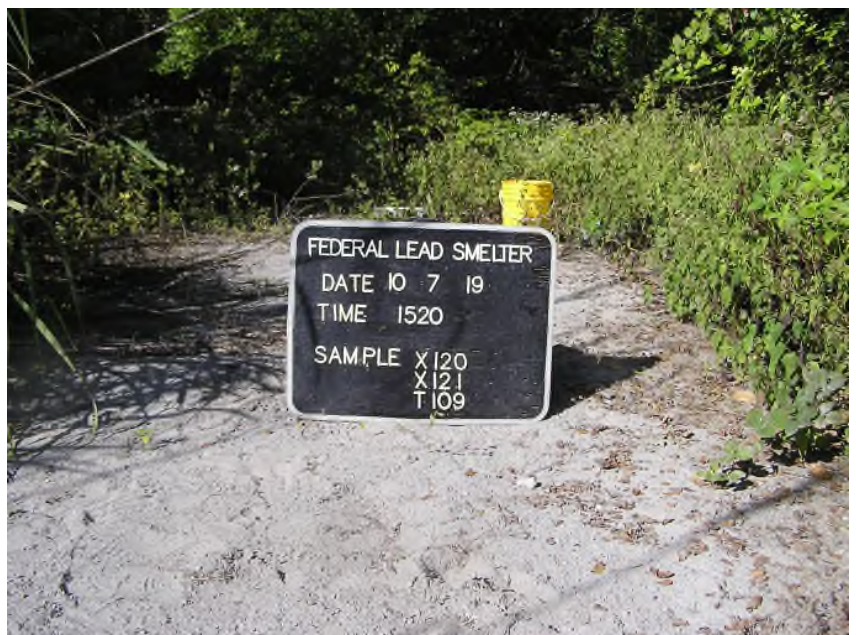
COMMENTS: Sample X120, X121 and TCLP 109 were collected on the waste pile on the south portion of the site. Material was gray, sandy silty waste. Collected from XRF 46 location. Sample X121 was a duplicate of X120.

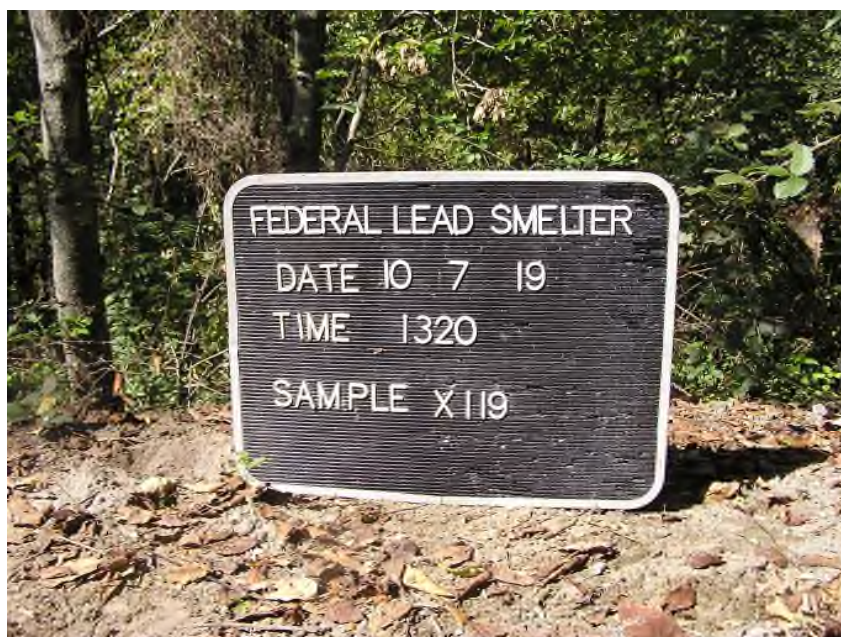
COMMENTS: X119 was collected from XRF 40 and 41 location. Sandy, silty waste material. Area had lots of kiln bricks.

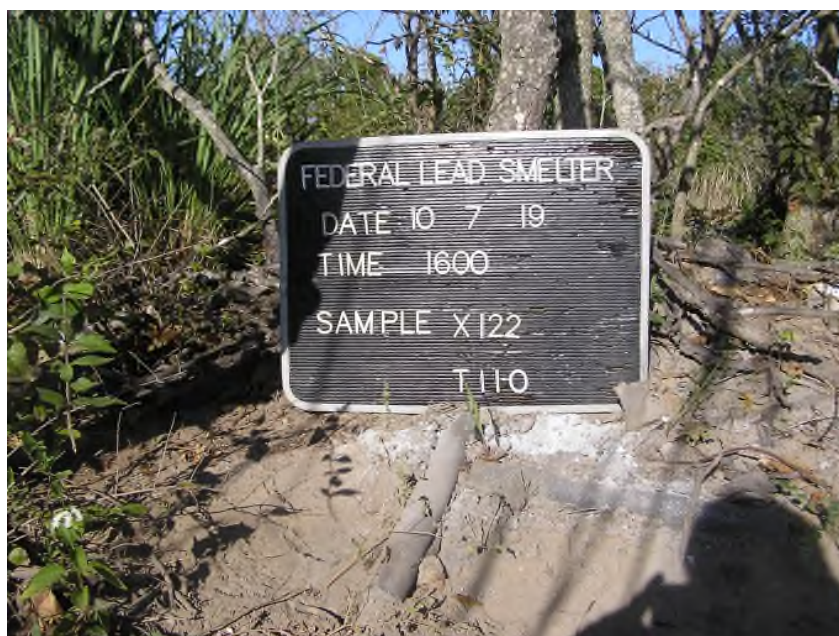
COMMENTS: X122 and TCLP 110 was collected from XRF 54 and consisted of grumpy, sandy, silty waste material. Sample was collected on waste pile. MS/MSD was collected from this location.

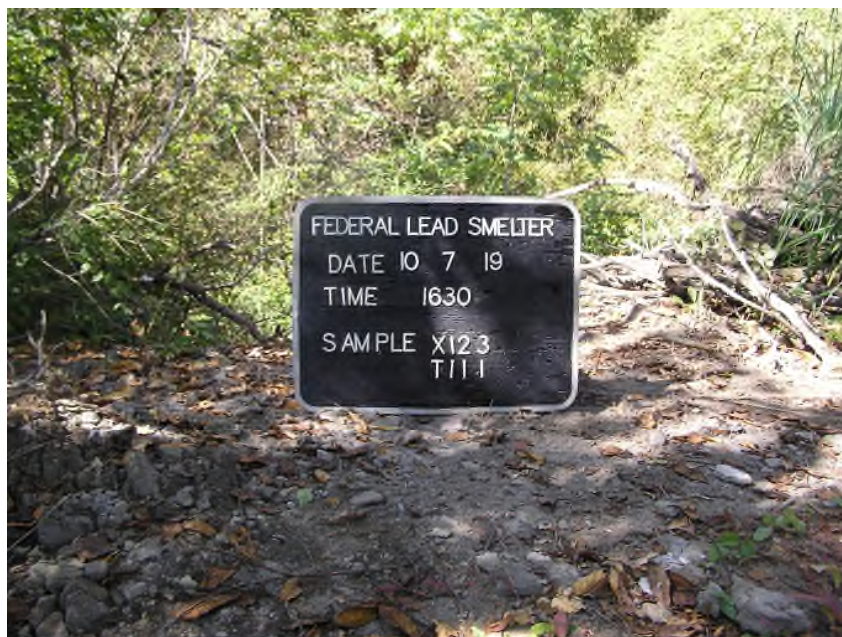
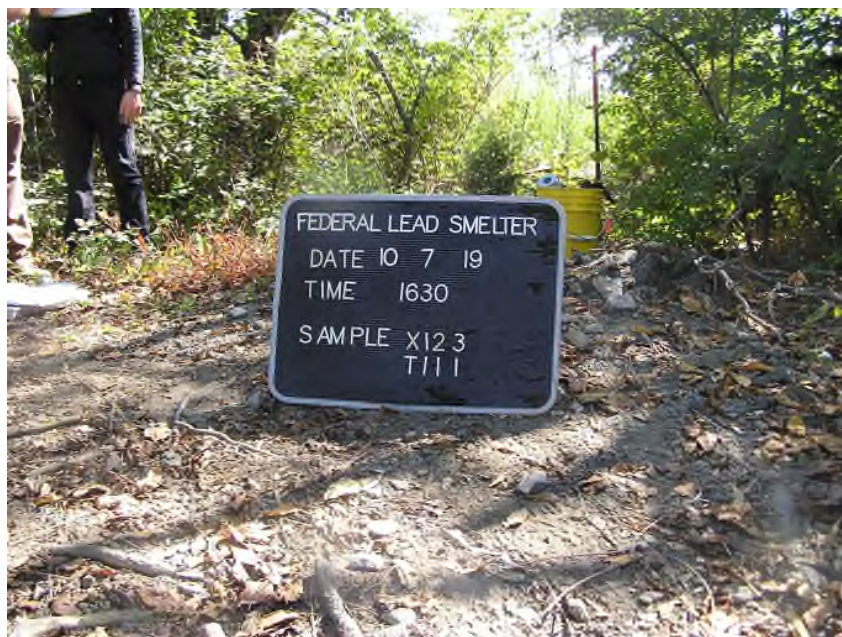
COMMENTS: Sample X123 and
TCLP 11. Material was gray,
sandy, silty waste. Collected from
XRF 60.

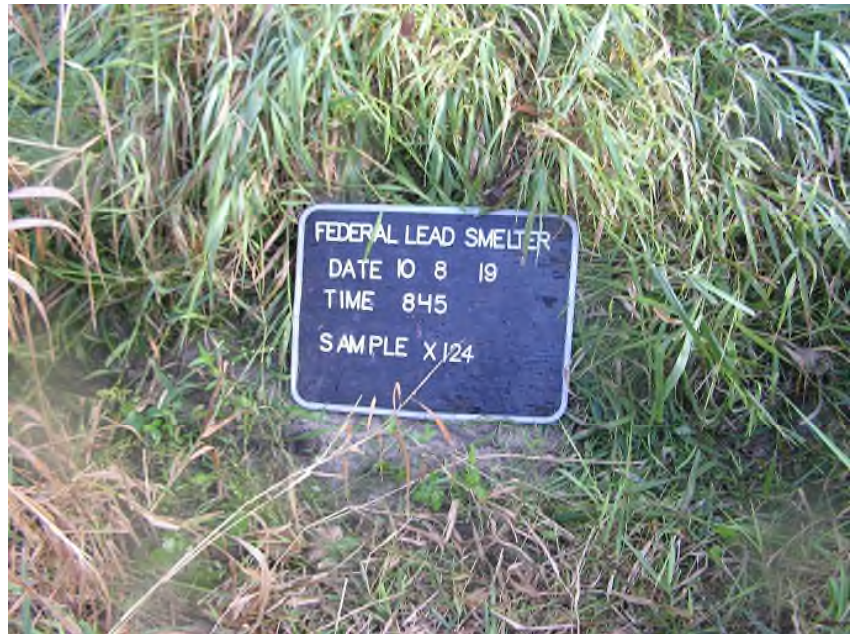
COMMENTS: X124 was collected from the surface of the drainage ditch and consisted of fine gray sand with some silt. Collected from XRF 2.

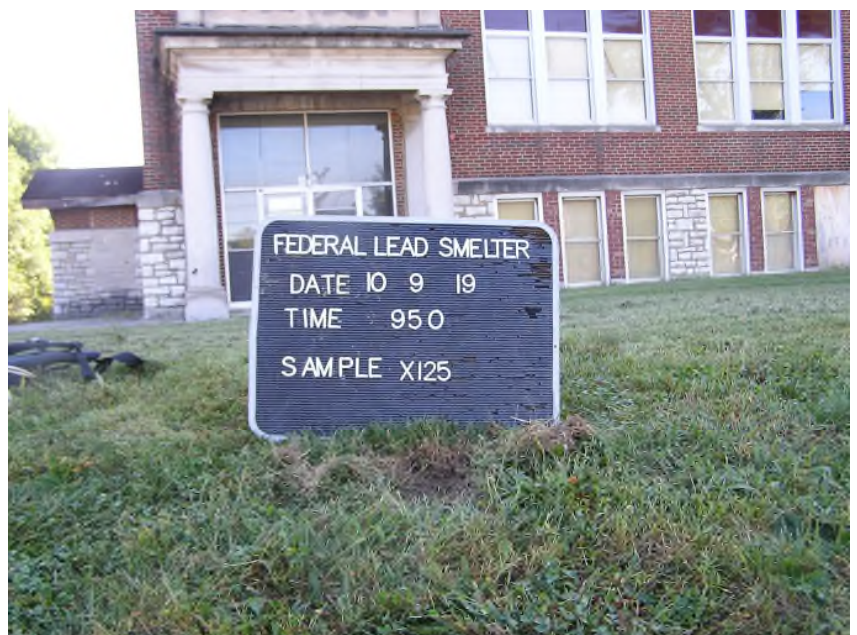
COMMENTS: X125 was collected from the Clara Barton School and was used as the background. Collected from 0-3 inches. Brown silty loam.

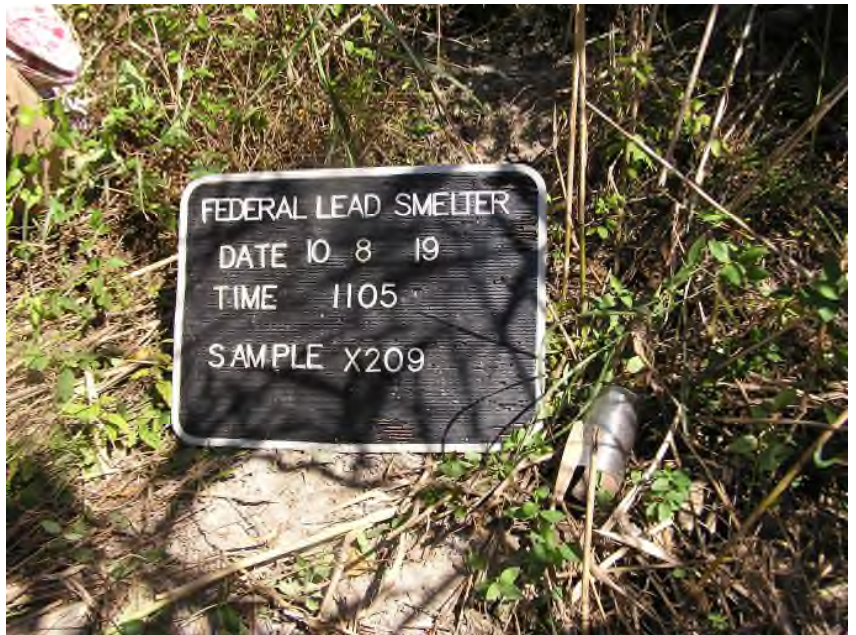
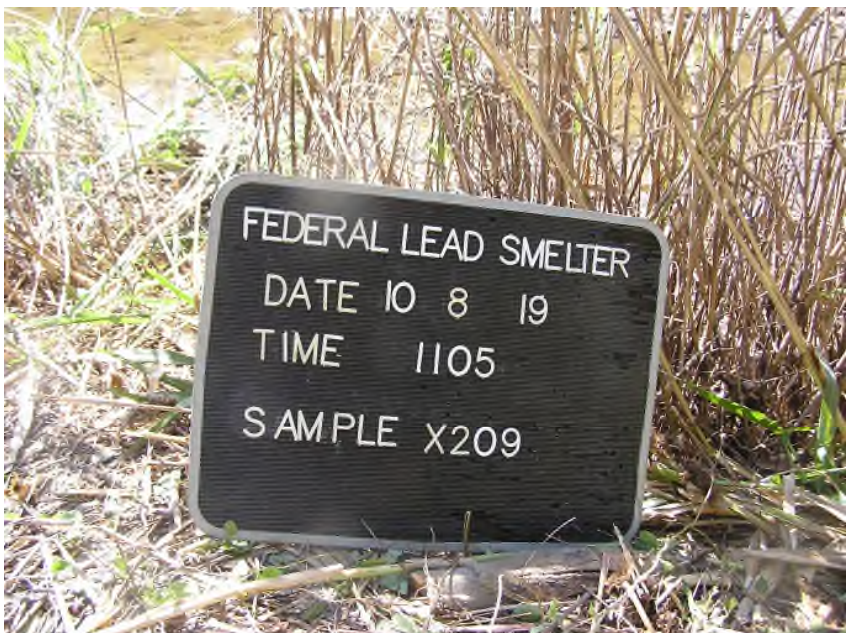
COMMENTS: X209 was collected
from the base of the waste pile in the
wetlands of the intermittent ditch.
Collected from XRF 22 location.
